Finding & Fixing Exhaust Leaks into the Z Interior

Z's are notorious for leaking exhaust gasses (or fumes) into the interior. This article details a process to find and eliminate the sources.

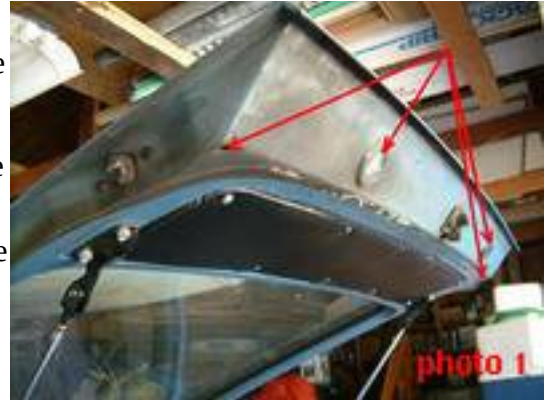
When driving with a window open, the air rushing around the windshield and drip mouldings creates low pressure in the front half of the open window. This vacuum is what draws the air in the back half of the open window, and ultimately draws in exhaust fumes through any leak near the back of the car. If the windows and doors do not seal well, exhaust is drawn in

(to a lesser effect), even with the windows closed. Granted when driving there is a low pressure area over the whole hatch and rear panel of the car, but not nearly as strong as the low pressure formed from an open window. The search to seal exhaust leaks should also improve heater performance, since you can also find and eliminate high pressure air leaks.

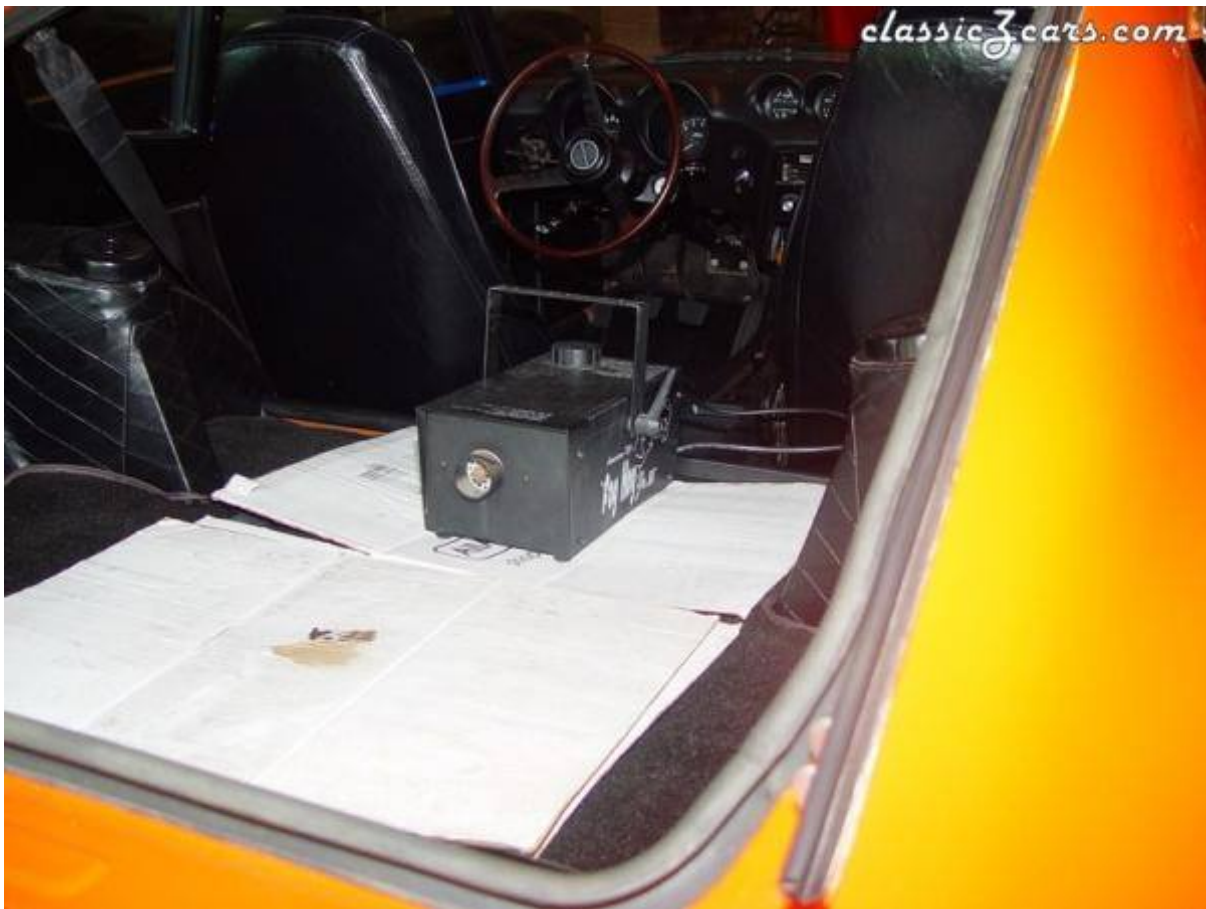
If using a smoke machine, set it on a piece of cardboard inside the hatch compartment (facing rearward) and send the power and remote cords out the passenger window.

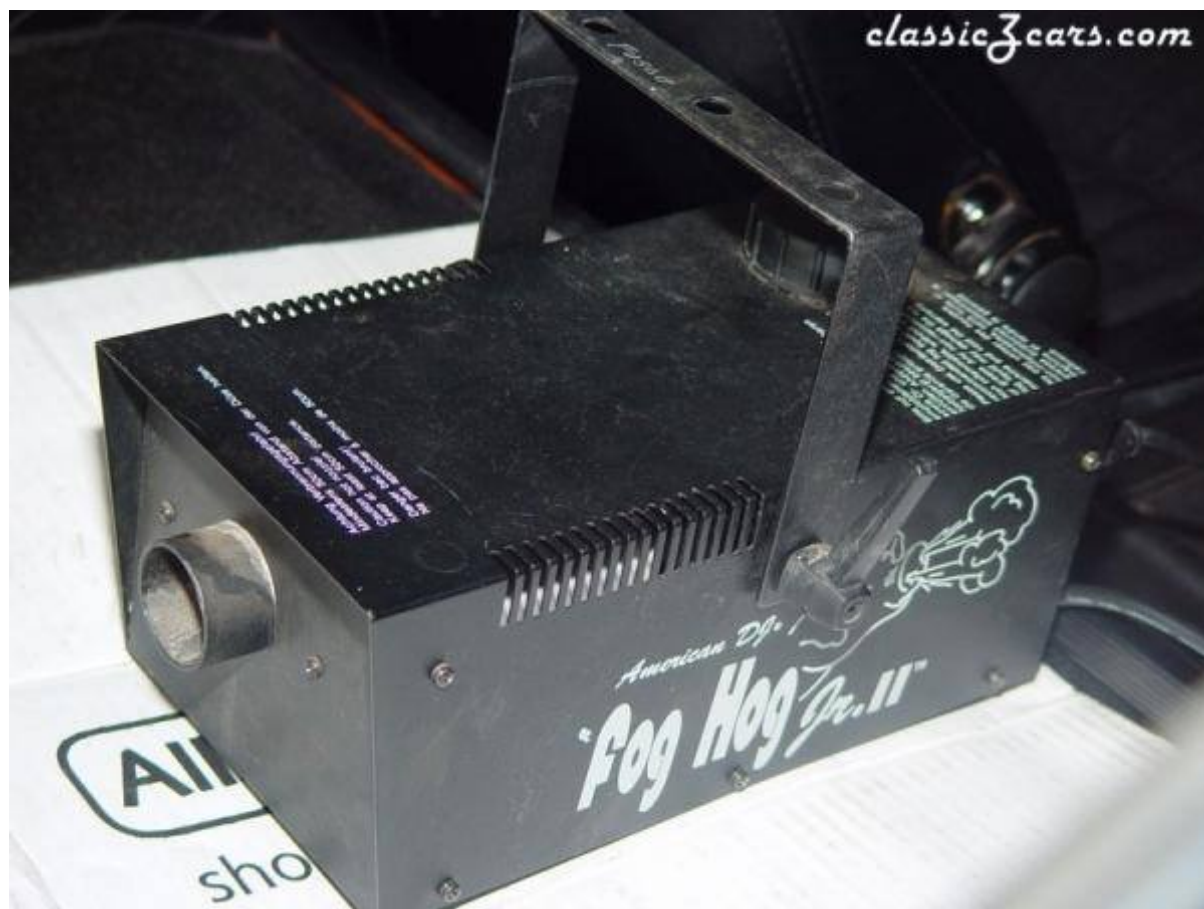
Close up of the Smoke Machine:

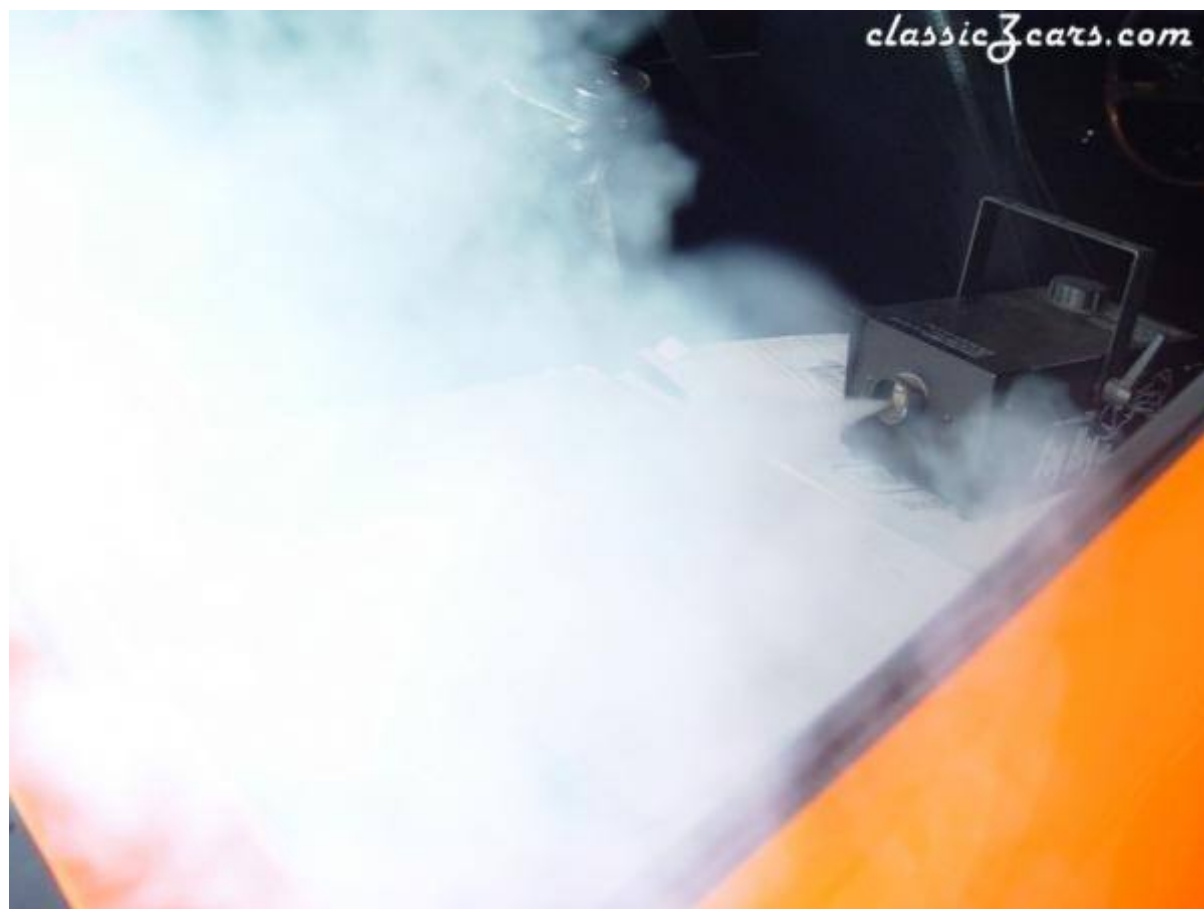
Test firing the smoke machine...

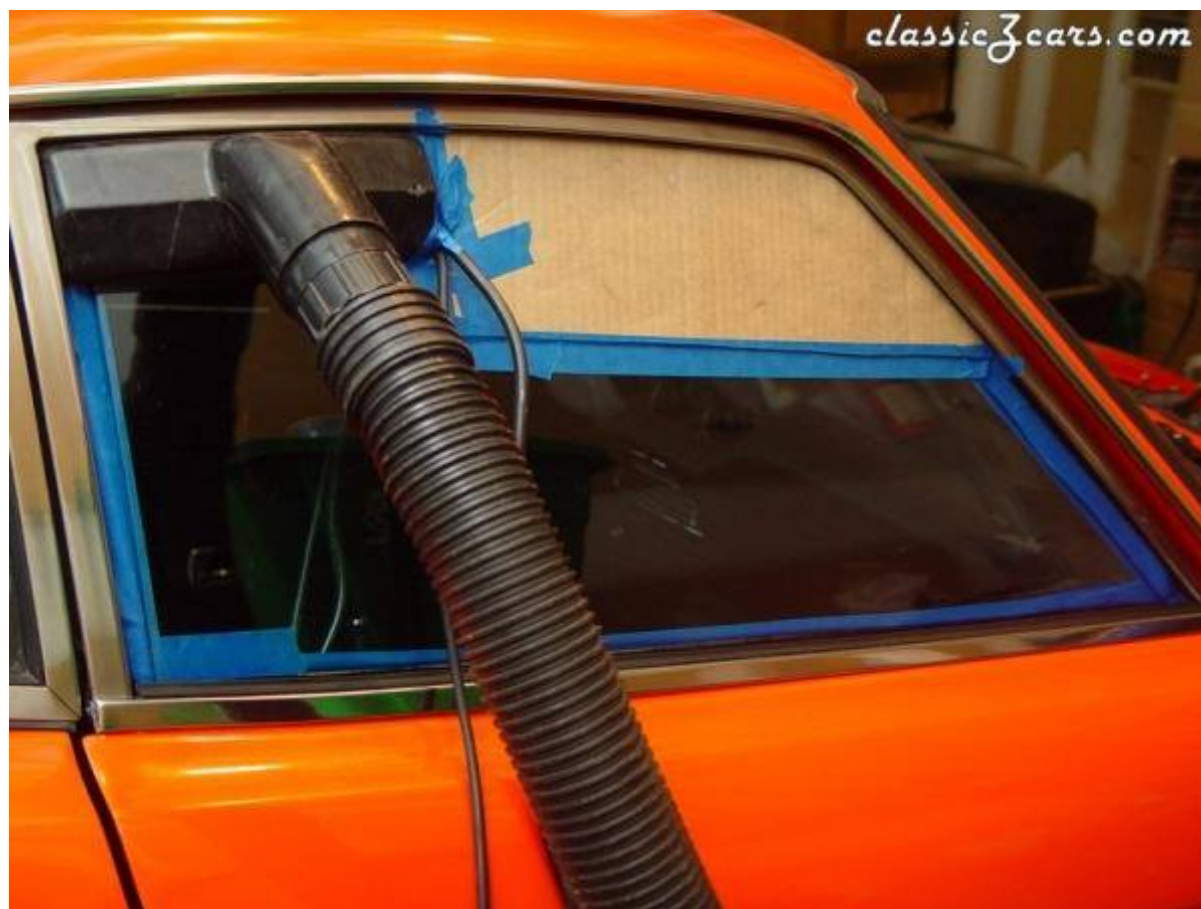
Open the passenger window about 3" and seal the shop vac floor nozzle to the upper rear corner of the window frame with tape. Cover the rest of the window opening with cardboard, and seal the opening inside and out with masking tape.

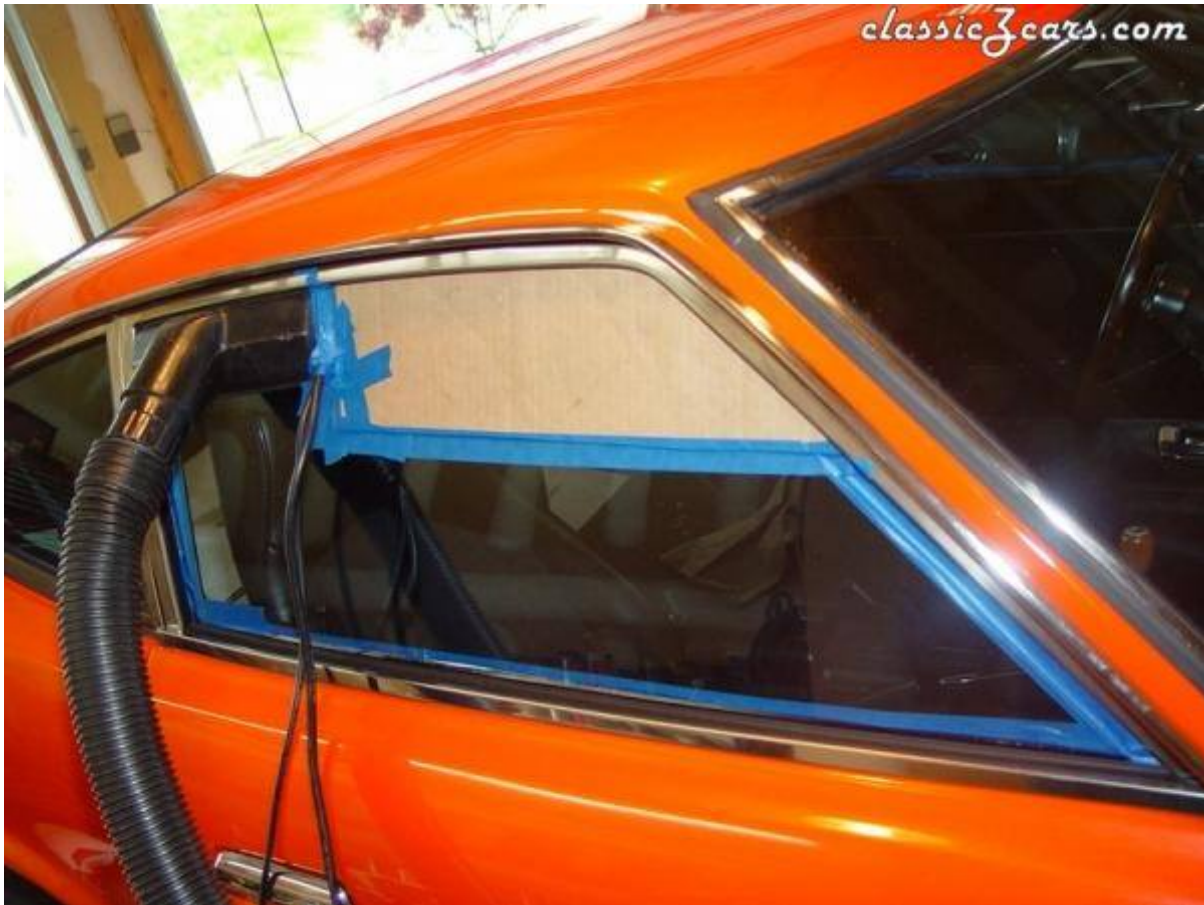
Another view:

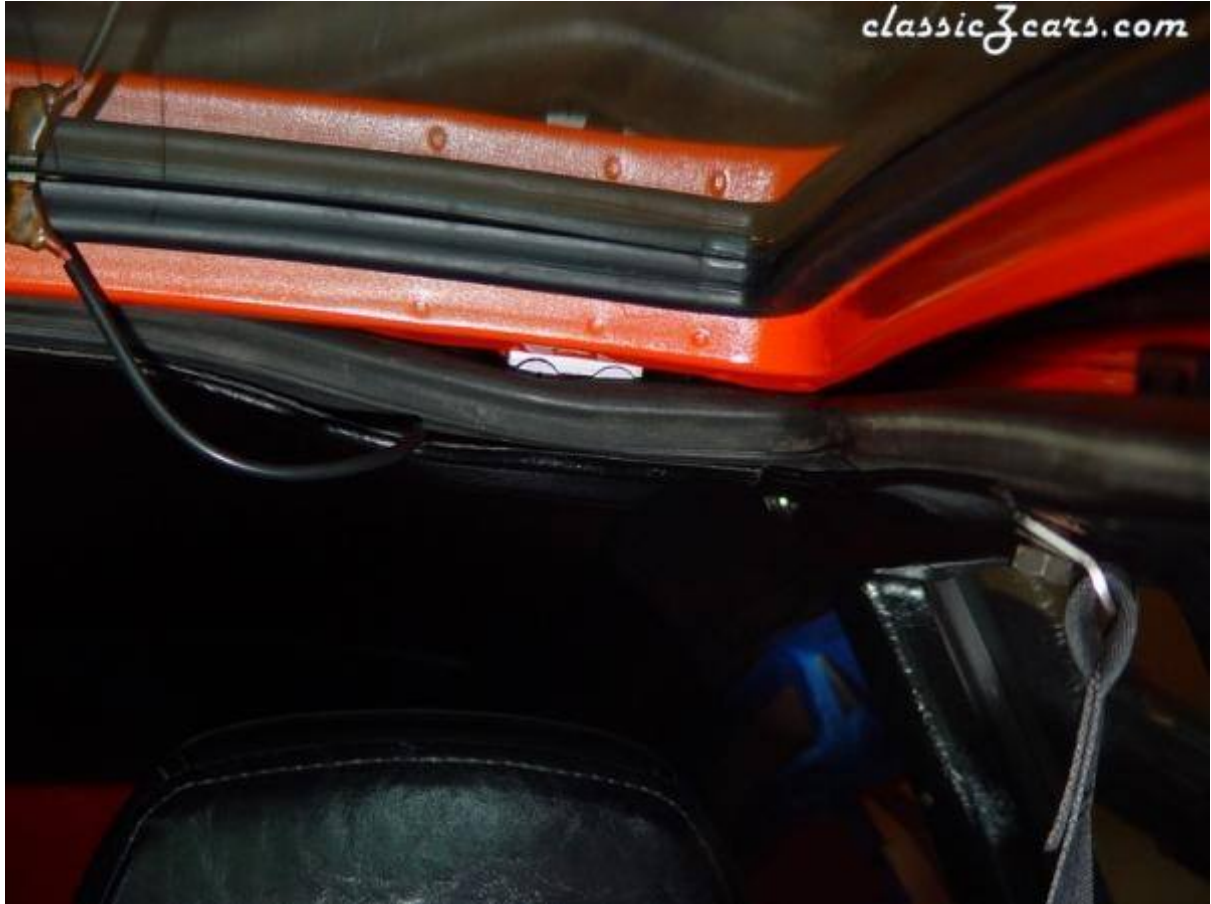
- Hatch seal: check alignment of hatch (adjust hinges & striker), replace hatch seal and/or add additional "universal" weatherstrip to close gap as needed. Even with a new gasket and properly adjusted hatch, I needed to add a trimmed strip of "universal" foam to each side in the hinge area to get a seal. This image is with the hatch slightly open, showing how the gasket touches the hatch on either side of the hinge, but leaves a gap in the hinge centers.

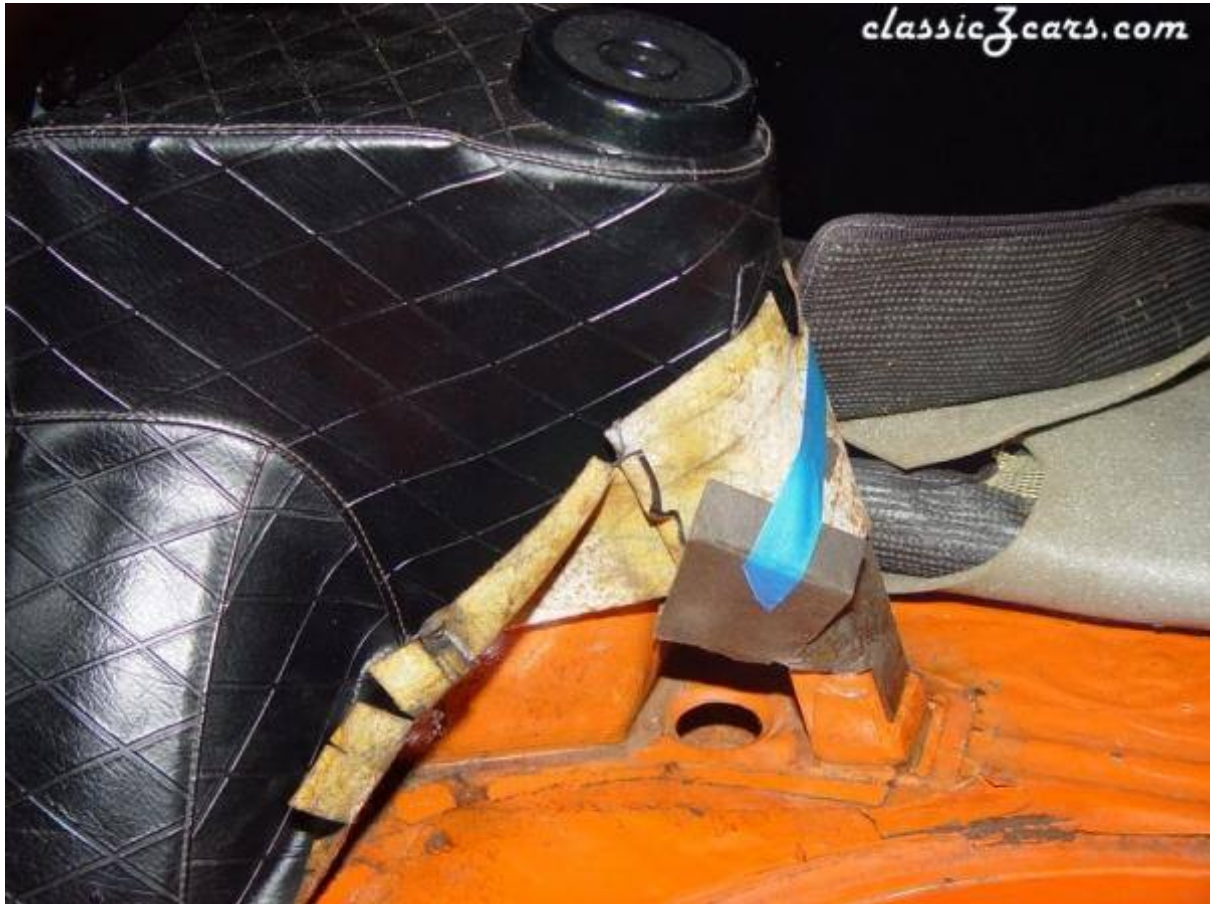
- Bottom of strut towers: under the diagonals for the strut towers (under the vinyl) there is a 1.5" diameter body hole with no grommet (this is over where the rear diff crossmember mounts to the frame rail). Where the diagonal mounts to the floor is also not fully sealed. All of these holes suck air through the frame rails. Nissan did not plug or seal these holes - the vinyl trim is supposed to seal off area. Either seal the vinyl to the floor, or peel back the vinyl and seal these areas (or do both).

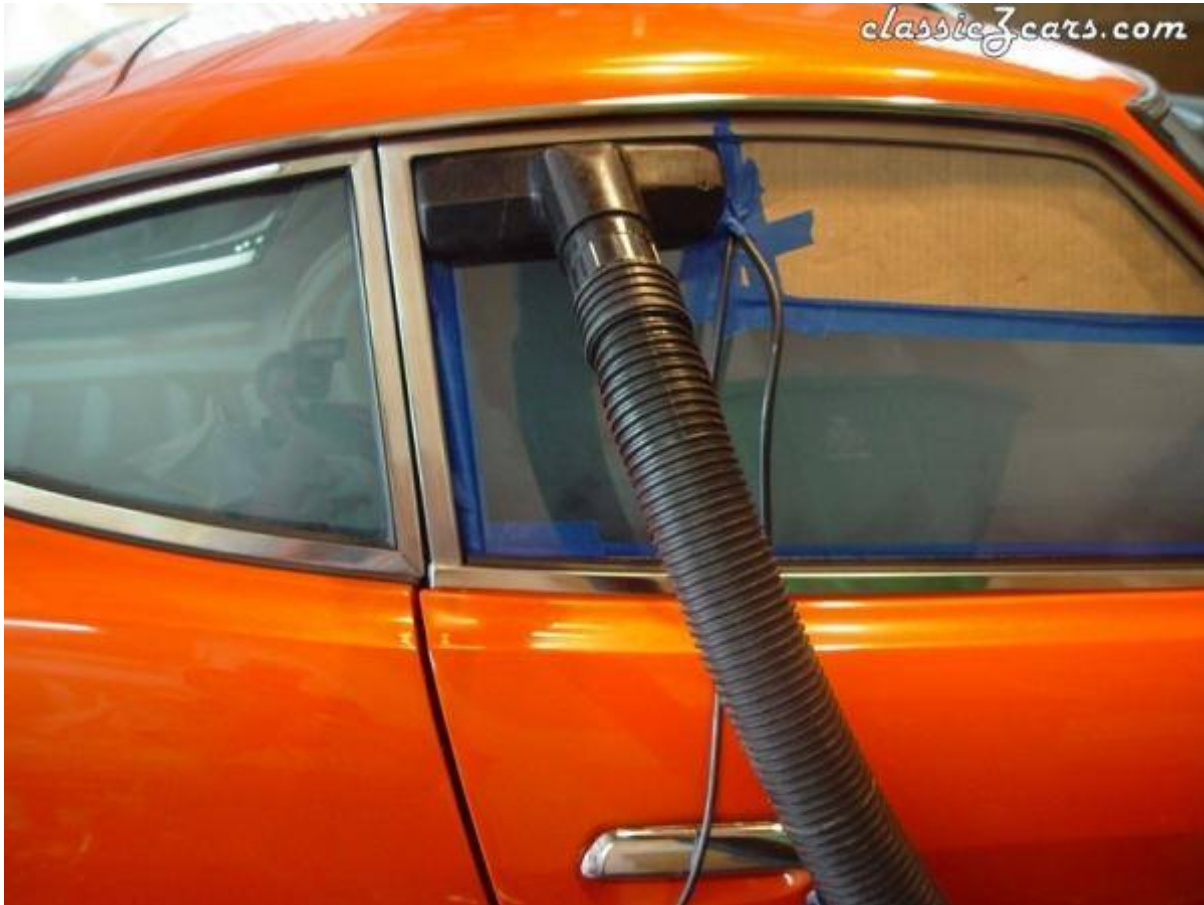
Filling up... (the smoke does not stain)...

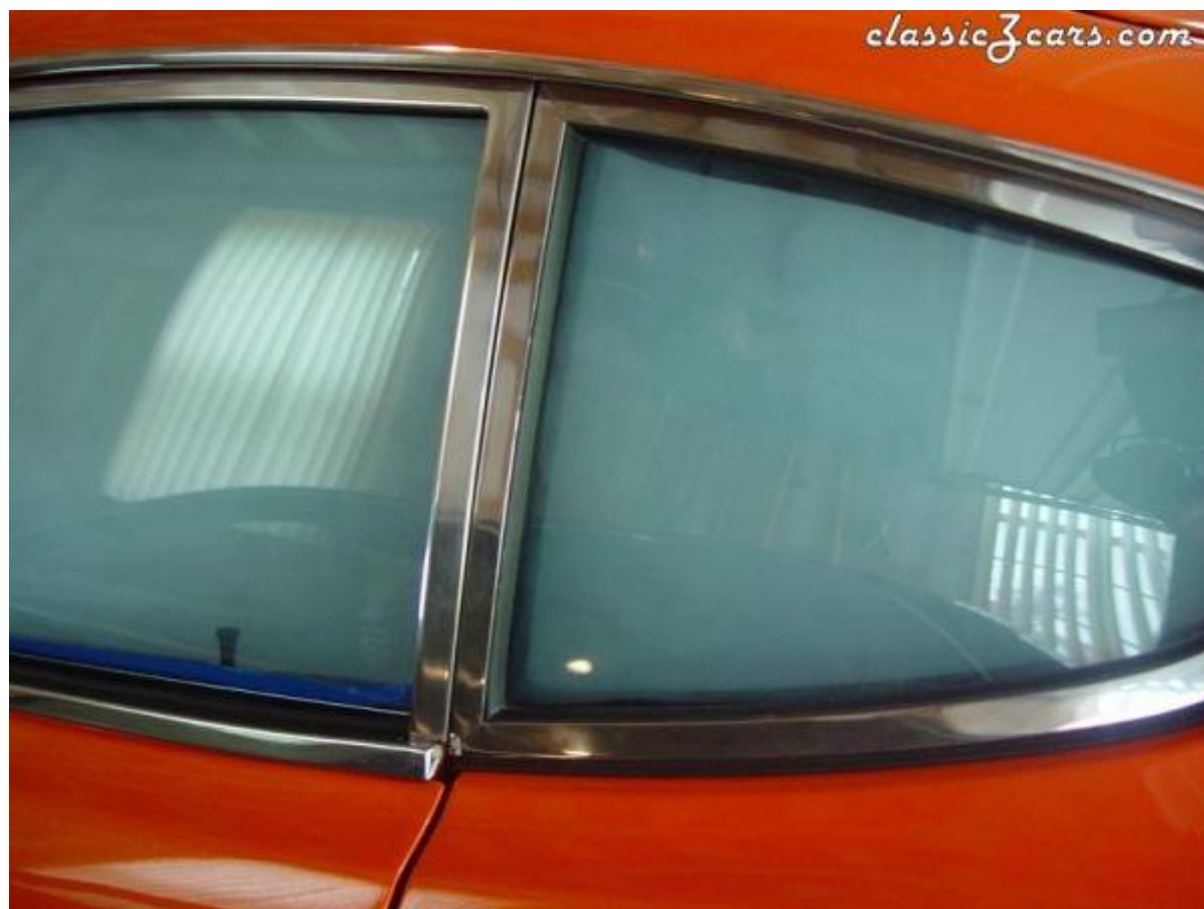
All Full!

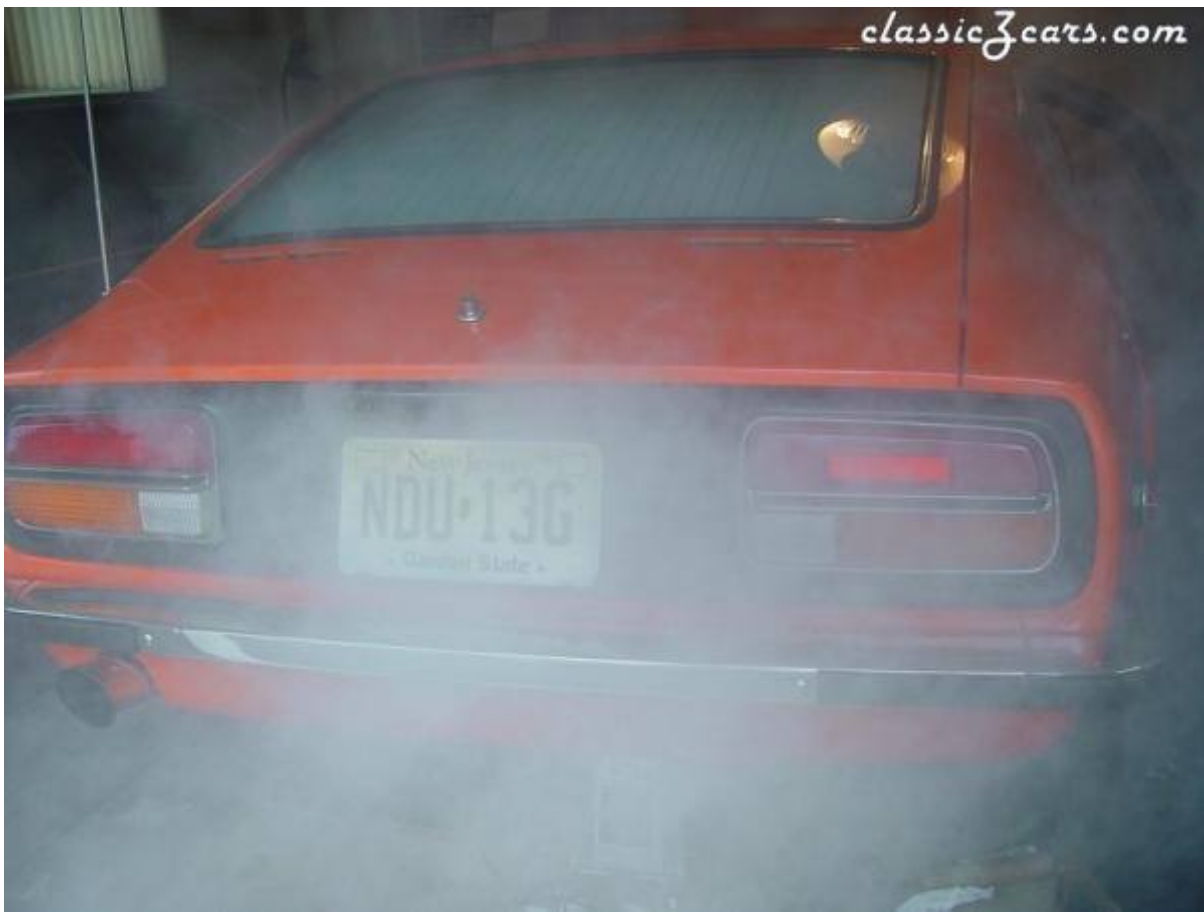
Turn on the vacuum and look for large leak areas (every Z has lots!).

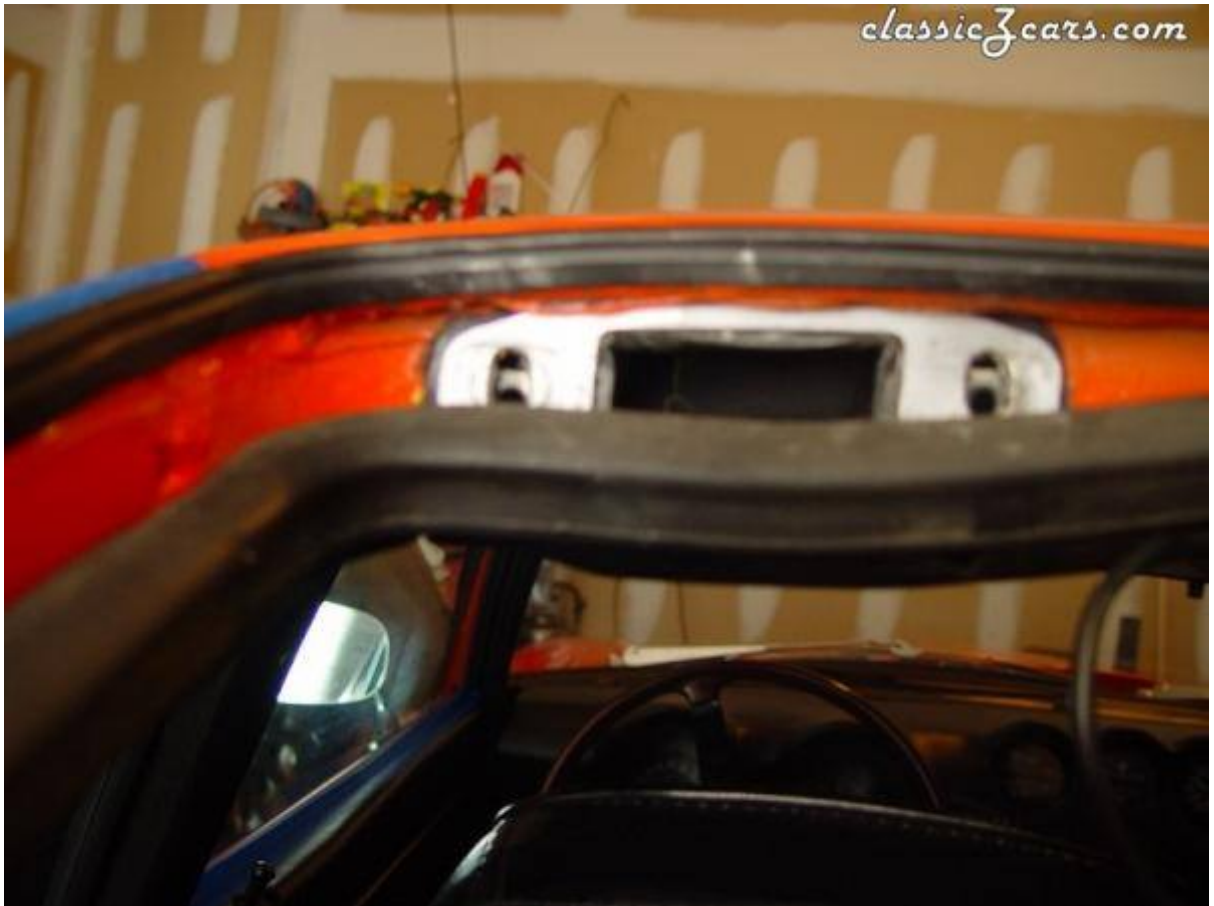
- This was a hard to find leak. In this photo, the hatch and hinges are removed. The hinges fit into a pocket along the roof edge. Behind the metal plate is a rubber boot that fits inside and seals the pocket. One of the pockets on this car had a crack deep inside the pocket and an area worn through from rubbing on the hinge. The part is no longer available from Nissan, so some glue and liquid rubber was used to seal it up. The gaskets also sealed poorly to the roof support (caulk sealed it up). There were also numerous leaks between the inner (thick) and outer (thin upper) gasket in the photo. Anywhere two pieces of sheet metal were spot welded together needed caulk.

- Round body plugs on either side of hatch rail.
 - Pinch weld above hatch hinges (just below the outer seal along the roof edge): caulk gaps.
 - Hatch hinges to the body: Seal any gaps (exposed adjustment or shim slots, seal the hinge gasket to the body, and if a pressure check confirms a leak from inside the hinge pocket, remove the hatch & hinges and seal any splits and cracks inside the rubber hinge pocket seals.

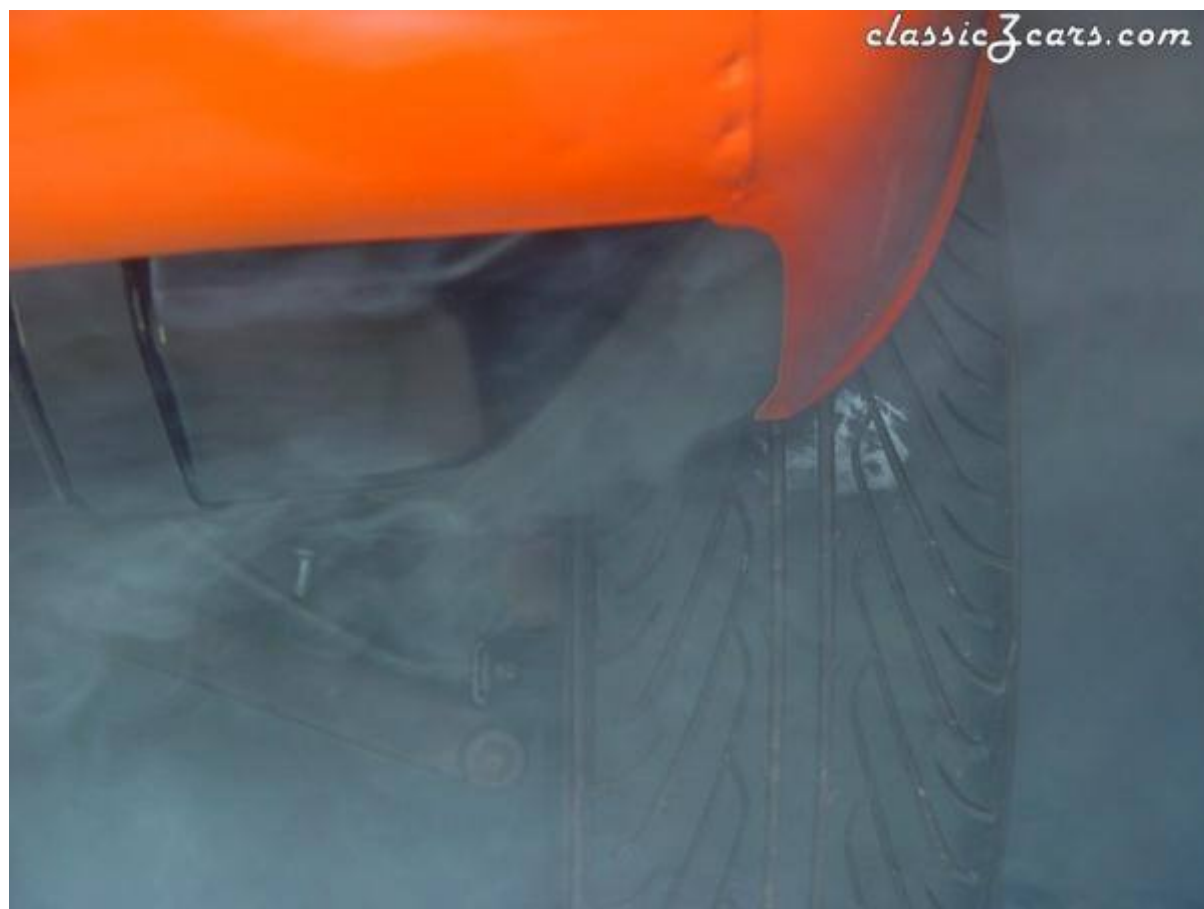
Continue the pressure test under the car: Note air leaks from fuel tank EVAP hoses and the associated grommets under the passenger rear.

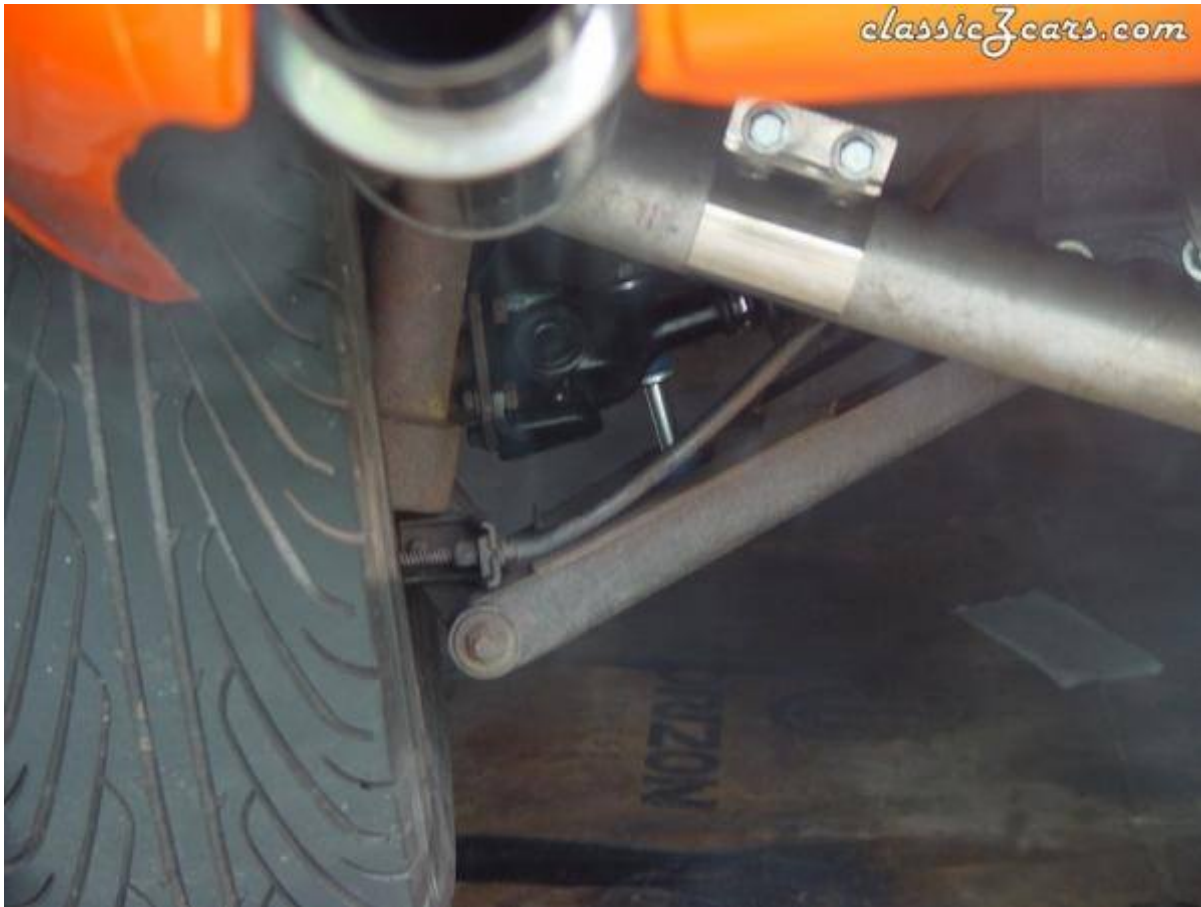
In the below photo, many leaks are sealed at this point, allowing the smoke coming from under the driver rear fender to be visible.
